OMC Project Description – Railway line-side structure monitoring

Overview

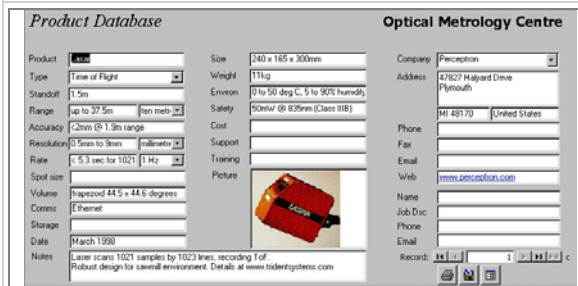
<p>Product Database Optical Metrology Centre</p> <p>Product: <input type="text" value="Time of Flight"/> Size: 240 x 165 x 300mm Company: Perception</p> <p>Type: Time of Flight Weight: 11kg Address: 27627 Maynard Drive Plymouth</p> <p>Standoff: 1.5m Environ: 0 to 50 deg C, 5 to 95% humidity</p> <p>Flange: up to 27.5m Safety: SClass @ 839nm (Class IIIb)</p> <p>Accuracy: 2mm @ 1.5m range Cost: Phone: NI 481 710 United States</p> <p>Resolution: 0.5mm to 5mm Support: Fax: Email: www.perception.com</p> <p>Rate: 5.3 sec for 1024 Training: Name: Job Desc: Phone: Email: Record: 11 11</p> <p>Spot size: Picture:

</p> <p>Volume: tapered 44.5 x 44.5 degrees</p> <p>Connx: Ethernet</p> <p>Date: March 1998</p> <p>Notes: Laser scans 1024 samples by 1023 lines, recording ToF. Robust design for sawmill environment. Details at www.tidestystems.com</p>	<p>OMC have a product database of more than 160 different measurement products. The requirements of the project were used to select the most appropriate technique and then identify a manufacturer for the equipment.</p>

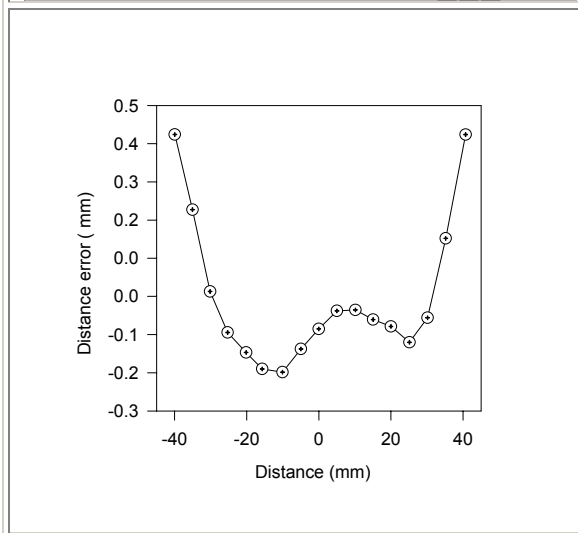
<p>Distance error (mm)</p> <p>Distance (mm)</p>

Distance (mm)	Distance error (mm)	-40	0.42	-35	0.22	-30	0.02	-25	-0.12	-20	-0.22	-15	-0.28	-10	-0.22	-5	-0.12	0	-0.02	5	0.02	10	0.02	15	-0.02	20	-0.12	25	-0.22	30	-0.02	35	0.12	40	0.42	<p>Laboratory testing of each selected instrument revealed characteristics that were not obvious from the manufacturers literature. In the example in the graph, where the accuracy of an optical triangulation sensor was being tested, the sensor showed some consistent systematic errors. In the case of another instrument a highly serious error was found where spurious measurements were given under some circumstances.</p>
Distance (mm)	Distance error (mm)																																				
-40	0.42																																				
-35	0.22																																				
-30	0.02																																				
-25	-0.12																																				
-20	-0.22																																				
-15	-0.28																																				
-10	-0.22																																				
-5	-0.12																																				
0	-0.02																																				
5	0.02																																				
10	0.02																																				
15	-0.02																																				
20	-0.12																																				
25	-0.22																																				
30	-0.02																																				
35	0.12																																				
40	0.42

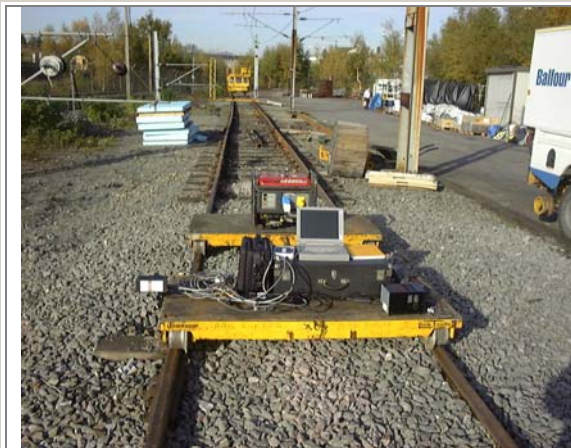
The tested instruments were taken on site where practical tests were conducted to assess performance in realistic conditions where temperature, sunlight or other factors such as vibration might affect the measurement process.

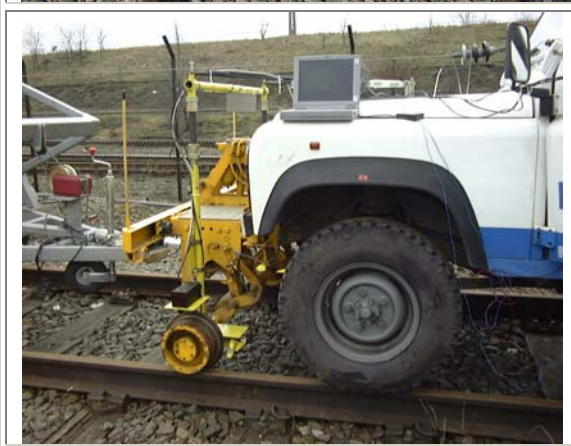
Further field trials were conducted using a modified Land Rover vehicle where all of the sensors were integrated together to measure camber, rail offset and distance to line side structures.

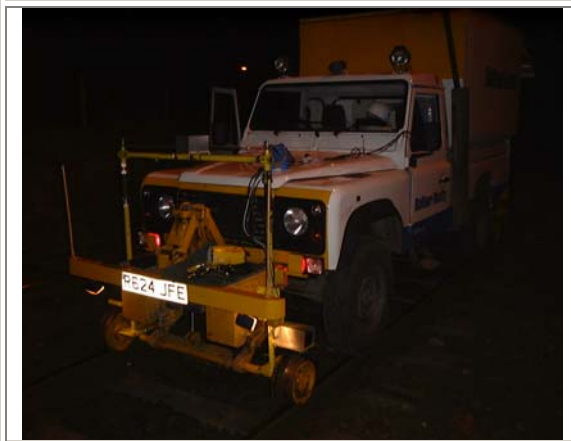
A night possession of a railway line was used to conduct a final test the system before commercial development was handed over to another company.
